RVI FOR INTERNAL HEALTH MONITORING OF INDUSTRIAL GAS TURBINES

BY PAUL THOMPSON

INDUSTRIAL GAS TURBINES ARE ROBUST, DURABLE, AND DEPENDABLE, BUT THEY CAN DEVELOP PROBLEMS SUCH AS INTERNAL WEAR, LOSS OF THERMAL BARRIER COATINGS, AND PREMATURE PART FAILURES. IF LEFT UNDETECTED, THESE ISSUES CAN LEAD TO SIGNIFICANT UNPLANNED COSTS AND DOWNTIME. TO PREVENT PREMATURE FAILURES, AND AS AN AID IN FUTURE OUTAGE PLANNING, INTERNAL HEALTH MONITORING USING REMOTE VISUAL INSPECTION (RVI) CAN DETERMINE WHETHER COMPONENTS ARE IN GOOD CONDITION AND FIT FOR SERVICE, OR IF ADDITIONAL REPAIRS ARE NEEDED. THE USE OF RVI, WITH A VIDEO BORESCOPE CAPABLE OF ANALYZING AND QUANTIFYING INDICATIONS USING 3D DATA DISPLAYED IN A POINT CLOUD, ALLOWS FOR MEASURING ANOMALIES WITH ACCURACIES OF 0.001 IN. (0.025 MM). IN SOME CASES, EARLY DETECTION AND 3D ANALYSIS OF INTERNAL ISSUES IN INDUSTRIAL GAS TURBINES HAVE SAVED OPERATORS MILLIONS OF DOLLARS, SOMETIMES EVEN DURING A SINGLE OUTAGE.

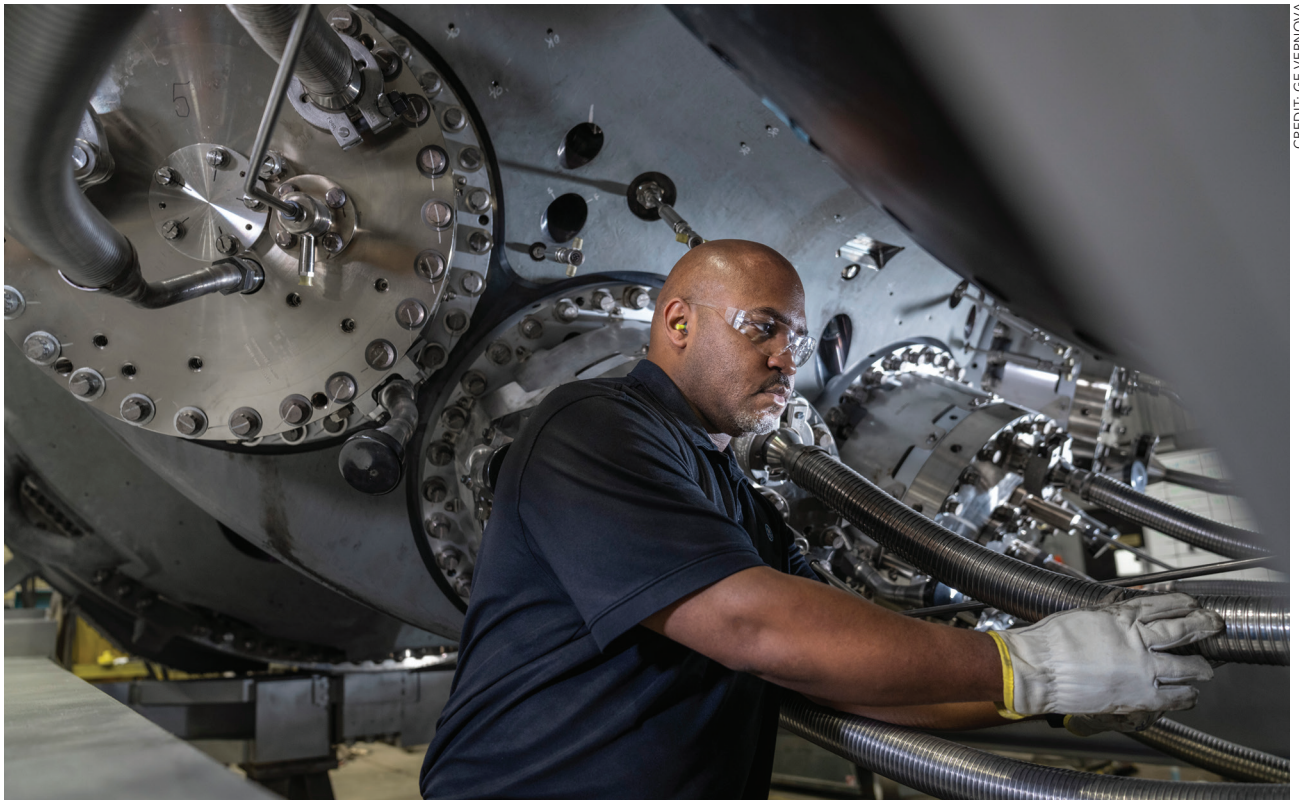
Figure 2. Visual inspection of a GE Vernova large frame gas turbine’s fuel lines.

Making a direct visual examination to determine the condition of internal components in a gas turbine is physically impossible without significant amounts of downtime and disassembly. As seen in Figure 2, a technician can readily inspect the internal components of a large frame gas turbine. When knowing their internal condition is required, this is where RVI becomes indispensable. It is interesting to note that while RVI is a subdiscipline of VT in SNT-TC-1A and ISO 9712:2021(en) visual testing (methods), both direct unaided visual tests and visual tests conducted during the application of another NDT technique are excluded. This

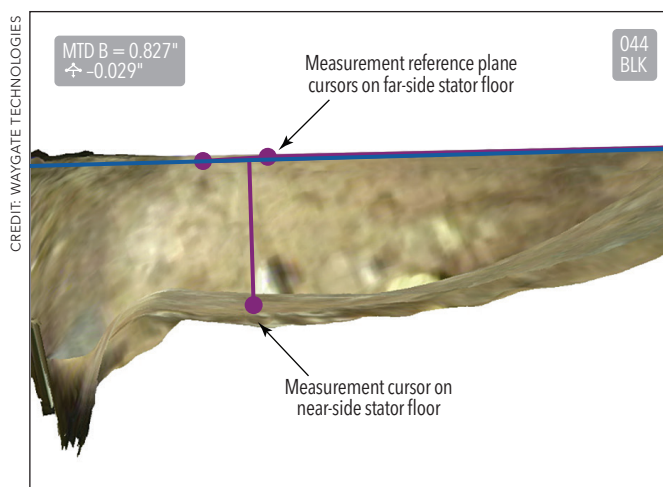
Figure 13. Full point cloud image of area being measured. Point cloud data depicts exactly the geometry of the surfaces being measured.

A magnified view of the point cloud image depicted in Figure 13 enables validation of the

correct placement of cursors on the surfaces and confirms that the point cloud data precisely replicates the surface being measured.
