RVI FOR INTERNAL HEALTH MONITORING OF INDUSTRIAL GAS TURBINES

BY PAUL THOMPSON

INDUSTRIAL GAS TURBINES ARE ROBUST, DURABLE, AND DEPENDABLE, BUT THEY CAN DEVELOP PROBLEMS SUCH AS INTERNAL WEAR, LOSS OF THERMAL BARRIER COATINGS, AND PREMATURE PART FAILURES. IF LEFT UNDETECTED, THESE ISSUES CAN LEAD TO SIGNIFICANT UNPLANNED COSTS AND DOWNTIME. TO PREVENT PREMATURE FAILURES, AND AS AN AID IN FUTURE OUTAGE PLANNING, INTERNAL HEALTH MONITORING USING REMOTE VISUAL INSPECTION (RVI) CAN DETERMINE WHETHER COMPONENTS ARE IN GOOD CONDITION AND FIT FOR SERVICE, OR IF ADDITIONAL REPAIRS ARE NEEDED. THE USE OF RVI, WITH A VIDEO BORESCOPE CAPABLE OF ANALYZING AND QUANTIFYING INDICATIONS USNG 3D DATA DISPLAYED IN A POINT CLOUD, ALLOWS FOR MEASURING ANOMALIES WITH ACCURACIES OF 0.001 IN. (0.025 MM). IN SOME CASES, EARLY DETECTION AND 3D ANALYSIS OF INTERNAL ISSUES IN INDUSTRIAL GAS TURBINES HAVE SAVED **OPERATORS MILLIONS OF DOLLARS, SOMETIMES** EVEN DURING A SINGLE OUTAGE.

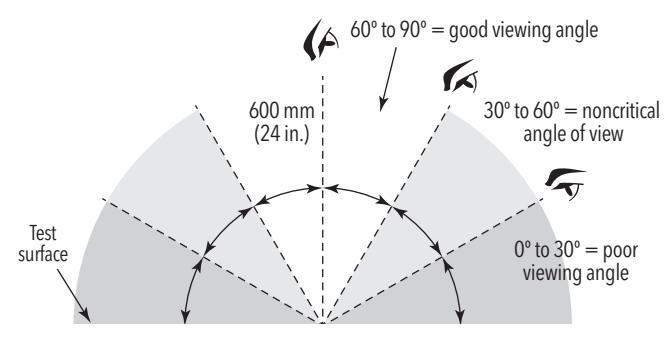
Figure 1. Direct visual testing viewing angle and distance.

(24 in.) of the object and positioned at an angle not less than 30° to the inspection surface, as shown in Figure 1 [1].

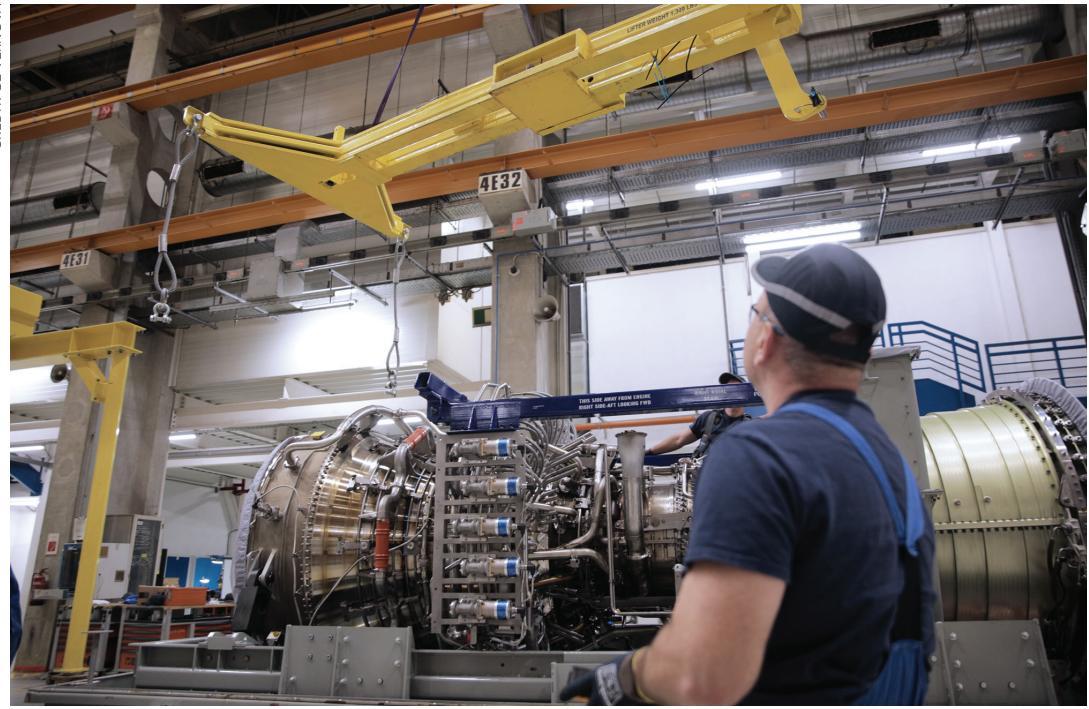
Figure 3. GE Vernova readies an LM6000 aeroderivative turbine for service.

Similarly, the GE Vernova LM6000 (LM is a Land Marine designation) aeroderivative turbine shown in Figure 3 was developed from the CF6-80C2 aviation turbine platform. The CF6 has been in use for over 50 years on long-haul flights by Boeing and Airbus. A cut-away of the CF6 as shown in Figure 4 depicts the major section of a gas turbine.

In power generation, there are also much larger and heavier frame turbines that have higher power output. However, both turbine types operate fundamentally the same, in that ambient air is compressed, mixed with fuel and heat in the combustion section, and then passes through a power turbine section where the energy is extracted. Notice the scale difference of the aeroderivative LM6000 in Figure 3 and the large frame 7HA.03 in Figure 5.

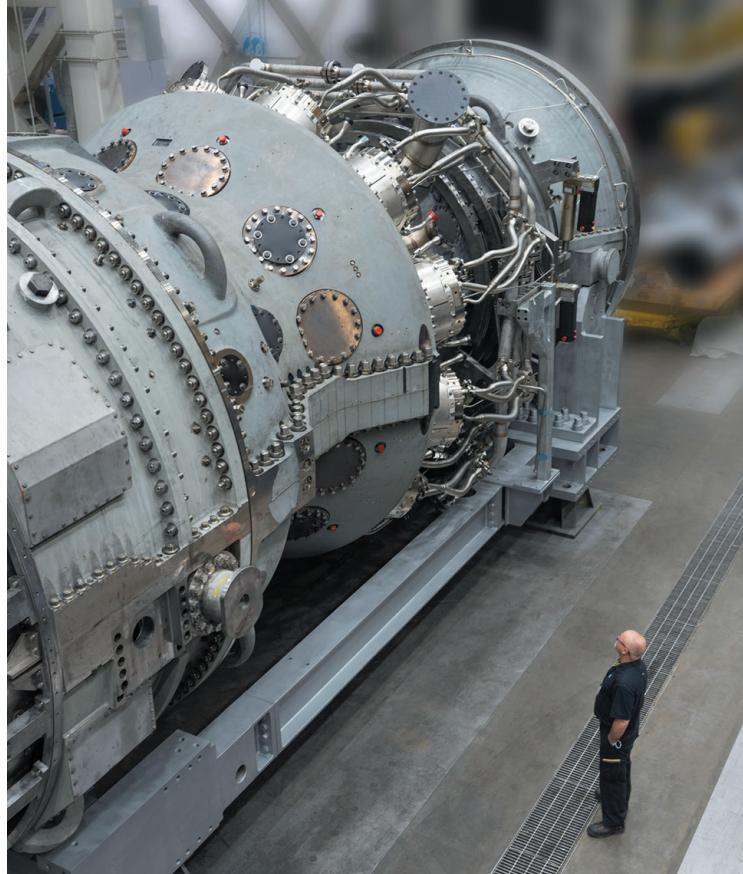
Figure 5. Large frame 7HA.03 GE Vernova gas turbine. a more frequent schedule to ensure flight safety. Another critical aspect of RVI for both aviation and industrial turbines is determining whether a turbine can operate safely and efficiently until the next scheduled inspection, thereby ensuring maximum uptime and profitability. This often involves needing to make precise and accurate measurements of various types of surface indications. A thorough understanding of RVI techniques, and the equipment being used, is critical for collecting accurate image data to make these assessments.

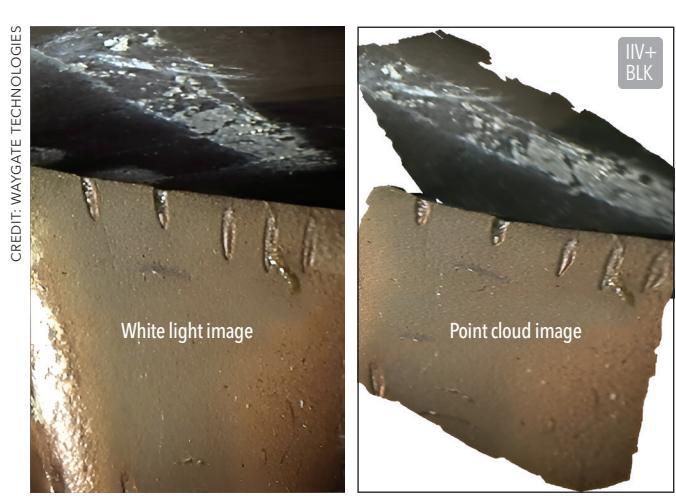
Figure 7. Power turbine blade tip-toshroud, measured with a stereo imagereference plane data was not validated. The darker top part is the shroud of the combustor; the bronzish lower part is a power turbine blade.

In the first example, Figure 7 shows a stereo measurement of a tip-to-shroud clearance being used to determine the wear of a power turbine's blade tips. The measurement type being used is referred to as a depth measurement. It can be thought of as measuring the distance to or from a reference plane established by placing three cursors on a reference surface. Then, by placing a fourth cursor on a point, one can calculate the distance of that fourth cursor above (+) or below (-) the reference plane. Blade tip-to-shroud clearance is important data for decision-making regarding the efficiency of the power turbine and assessing the need for repairs.

As seen in Figure 7, three points of a mathematical reference plane appear to be on the shroud's surface: the cursors labeled 1,2, and 3. (Pay particular attention to the plane's cursor labeled 3.)

The fourth cursor, labeled 4, is placed on the tip of the blade and provides a measurement from the reference plane on the shroud to the blade tip.

In Figure 7, the measurement data of 0.031 in. (0.787 mm) may be considered accurate because cursors 1, 2, and 3 for a reference plane appear on the shroud (the darker surface in the upper portion of the image), and the measurement cursor (cursor 4) appears to be placed on the tip of the blade (the bronze-colored surface in the lower portion of the image).

In the example in Figure 7, the technician was not trained in how to validate the measurement data in a stereo image, nor were they trained to review the point cloud data and the cursor placement upon the data. This led to providing a blade tip-to-shroud clearance data of 0.031 in. (0.787 mm).

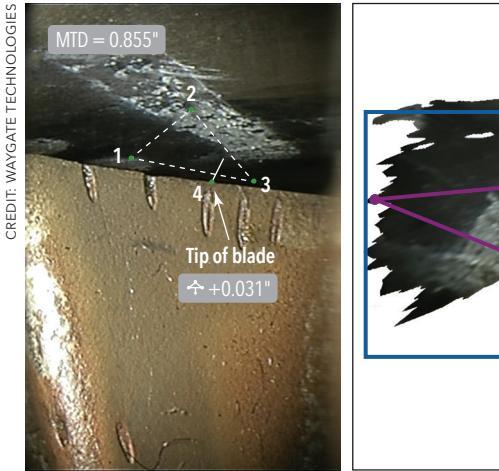
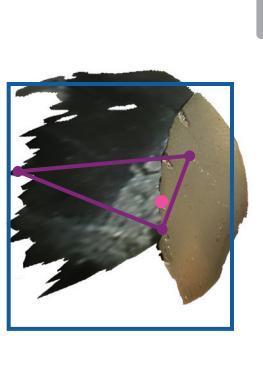
Figure 6. Power turbine shroud (darker top part of image) and blade tip (bronzish lower part of image) as seen in a white light image (left) and an XYZ 3D point cloud (right).

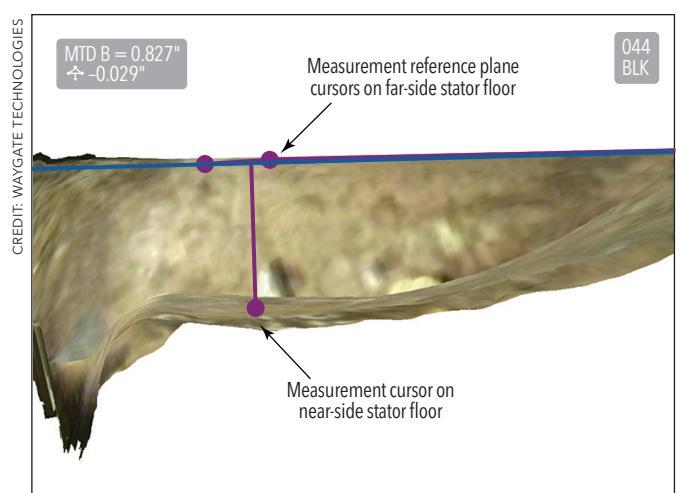
Figure 13. Full point cloud image of area being measured. Point cloud data depicts exactly the geometry of the surfaces being measured.

A magnified view of the point cloud image depicted in Figure 13 enables validation of the

correct placement of cursors on the surfaces and confirms that the point cloud data precisely replicates the surface being measured.
